December 2021 C-130 Newsletter

C-130J - HF Antenna Deicing Boot and Saddle Improvements

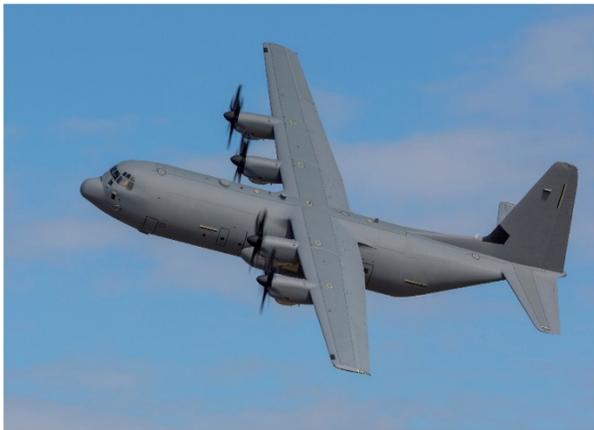
The Lockheed Martin C-130J was designed to fly Faster, Farther, and Higher than the original C-130 Hercules. One visual cue to tell if a Hercules is a C-130J is the black deicing boot and saddle on the base of the vertical stabilizer. This combination is the HF Antenna. During portions of the flight testing, it was discovered that ice was building on the lower section the vertical stabilizer. The design engineers in Marietta, Georgia modified a composite saddle fairing with rubber boot combination that would prevent the buildup of excessive ice on this area of the lower vertical stabilizer. The inflatable rubber boot is attached by an adhesive onto the composite saddle. This effective design allows the boot to inflate and deflate to prevent ice from forming in this critical area. Many years later this boot is still doing the job those engineers designed it to do by preventing ice accumulation. One of the fundamental goals of Lockheed Martin is to support our customers by developing better and more cost-effective ways to sustain its multiple lines of aircraft.

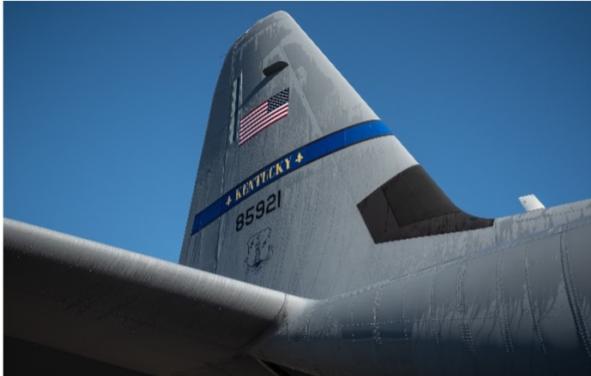
The first decision was to extend the life of the pneumatic deicer boot by applying a conditioner. The intent of the conditioner is to keep the rubber soft and pliable preventing the pin hole leaks that often lead to replacement of the boot and subsequently, the saddle. Age Master Rubber Protective Agent was the product selected to keep the rubber protected from the weathering elements. The conditioner is applied at scheduled intervals per the 30JG-00-1, Application of Rubber Protective Agent to Vertical Stabilizer Deicer Boot to ensure the boot remains healthy for longer periods of time. This extends the overall health and life of the rubber boot.

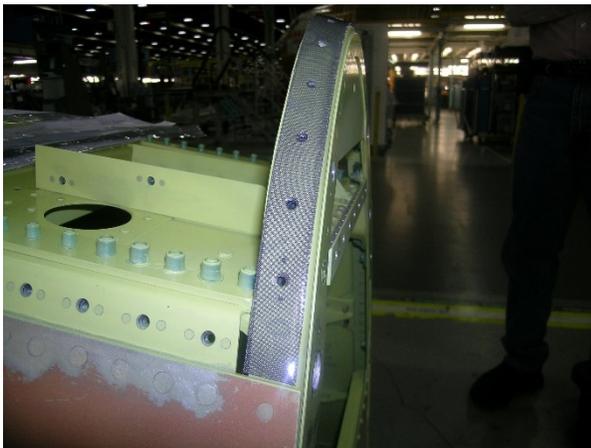
Aviation Devices and Electronic Components LLC produces multiple types of sealant tapes and gaskets that could be used at this location, but the final solution would eventually utilize a hybrid configuration of both the HT3000RT tape with a Conductive gasket and utilize Thixoflex for the final Aero seal. The HT3000RT tape was used on the top, left, and right sides of the installation. This tape is a polyurethane gel tape that has Teflon on one side. The polyurethane side of the tape protects the aircraft structure from corrosion while the Teflon side allows for easy removal of the saddle in the future. The conductive gasket which mounts to the leading edge of the saddle is also made of polyurethane gel with a wire mesh. This conductive gasket on one edge of the saddle fulfilled the conductive requirement for the entire saddle. A conductive gasket was also implemented on the left and right-side access panels of the boot to ease access instead of using sealant. During this evaluation a fit check was performed at the Lockheed Martin Marietta production facility with exceptional results. The production technicians liked using a tape instead of a sealant on the mating surfaces. A seasoned aircraft maintainer and production technician said, “working with sealant often is just plain messy. I get sealant on my clothes and it’s hard to clean up. The sealant ends up all over everything even when you’re careful. The less sealant we can use on a job the better”. Using the Aviation Devices and Electronic Components LLC tape and gasket solution on the mating surfaces reduces that mess, Thixoflex is then used for the final Aero sealing and smoothing between the saddle and the vertical stabilizer structure. Thixoflex is a fast-curing polyurethane type sealant alternative that is often used in combination with the Aviation Devices and Electronic Components LLC tapes and gaskets. After the final solution was developed the next step for this project was to update the C-130J fleet maintenance manuals.

Subsequently every C-130J operator's maintenance manual procedures were revised to include the new Aviation Devices and Electronic Components LLC conductive gasket, tape combination with the Thixoflex as an option to the traditional separable fay surface sealing. These updated procedures are found in the 23JG-20-1, Removal and Installation of the HF Antenna. By using the tape and gasket combination on the vertical stabilizer saddle, removal damage has been considerably reduced. Damage and rework of the mating structure has also been lessened. The aircraft down time to change the saddle and boot combination has also been slashed. Operators are liking the benefits of using the Aviation Devices and Electronic Components LLC gasket and tapes.
